MISCELLANEOUS PAPER S-71-27

DESIGN OF UNSURFACED SOIL FACILITIES FOR OPERATIONS OF C-5A AIRCRAFT

D. M. Ladd, V. C. Barber

Conducted by U. S. Army Engineer Waterways Experiment Station, Vicksburg, Mississippi

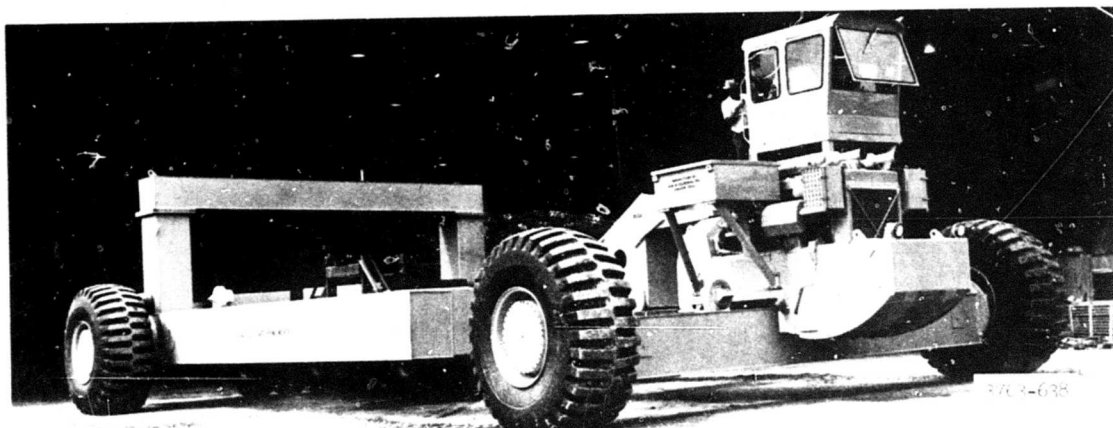
Fig. 1. Load cart used for C-5A tests

6. The load cart used to apply traffic to test section 1 and to lane 2 of test section 2 is shown in fig. 1. This load cart is driven by electric motors in each wheel and consists of a power unit and frame

and two interior load compartments with the tracking wheels. Weights were placed in the load compartments to provide the desired test load of 252,000 lb, which is the load on 12 main gear tires of the C-5A at a gross load of 571,000 lb. The configuration and tire size of the tracking wheels were the same as one main landing gear of the C-5A aircraft. The load boxes are interconnected, and the forward box is connected to the frame by two draw pins. The boxes are free to move in a vertical direction independent of the frame. This load cart was operated in such a manner that the wheels of the frame did not traffic the test lanes.

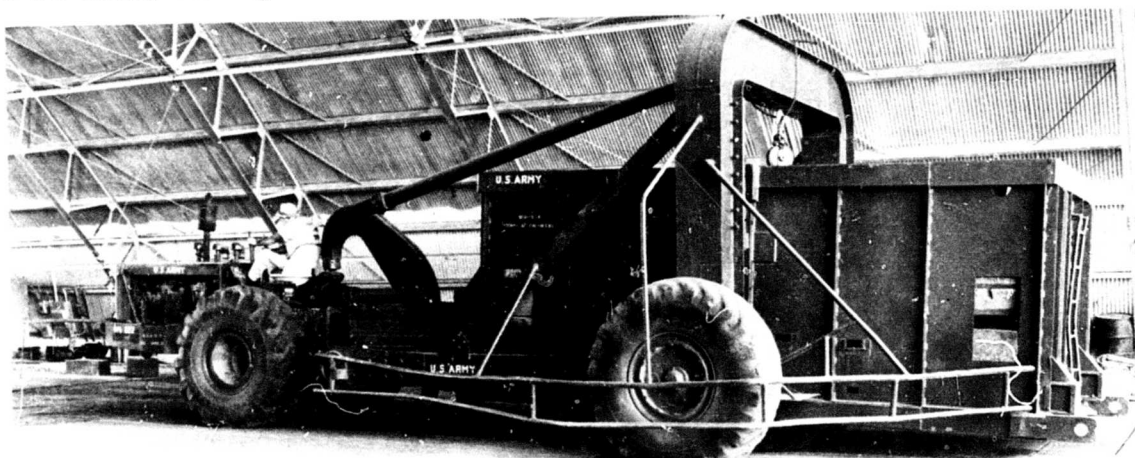
Fig. 2. Load cart used for single-wheel tests

7. The load cart used to apply traffic to lane 1 of test section 2 is shown in fig. 2. The cart is drawn by a commercial-type tractor

and consists of an interior load compartment with loaded tracking wheels and an outer support frame. The load compartment is connected to the frame by a single draw pin in the front, providing free vertical movement independent of the frame. The wheels of the tractor trafficked the test lane, but the weight and tire pressures were small and this traffic was considered negligible.

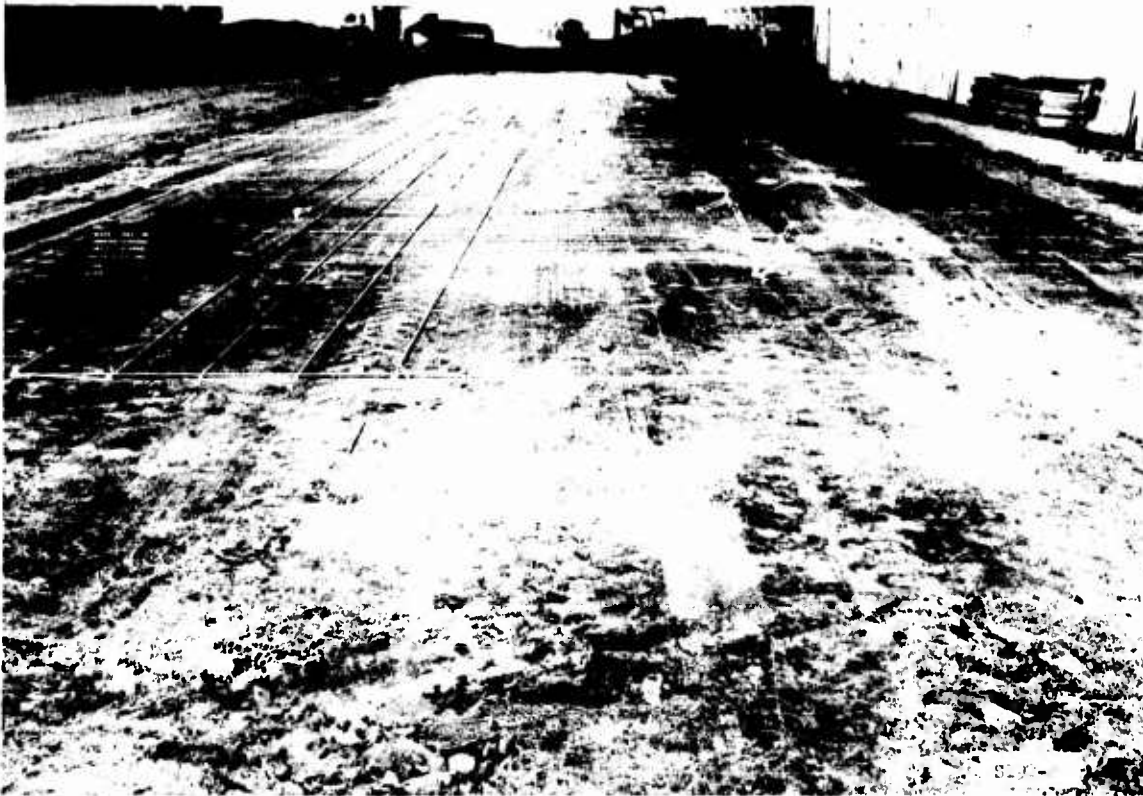
Photo 1. Test section 1, item 1, prior to traffic

19. Item 1 prior to traffic is shown in photo 1. After two passes with the test vehicle, rutting was negligible. After 96 coverages, the maximum rut depth measured was 2.6 in. (photo 2). Traffic was continued to 128 coverages, at which time severe rutting had developed and item 1 was considered failed (photo 3).

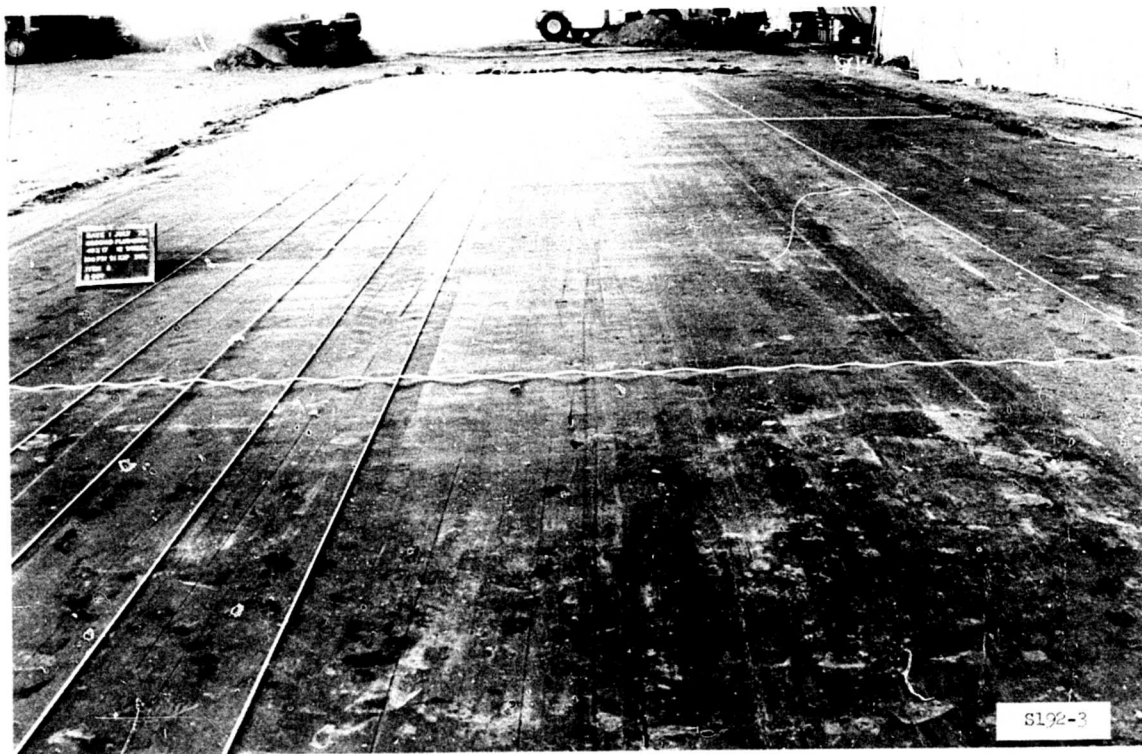
Photo 4. Test section 1, item 2, prior to traffic

20. Item 2 prior to traffic is shown in photo 4. Moderate rutting developed in item 2 at two passes of the load vehicle, and at 16 coverages, the item was considered failed (photo 5).

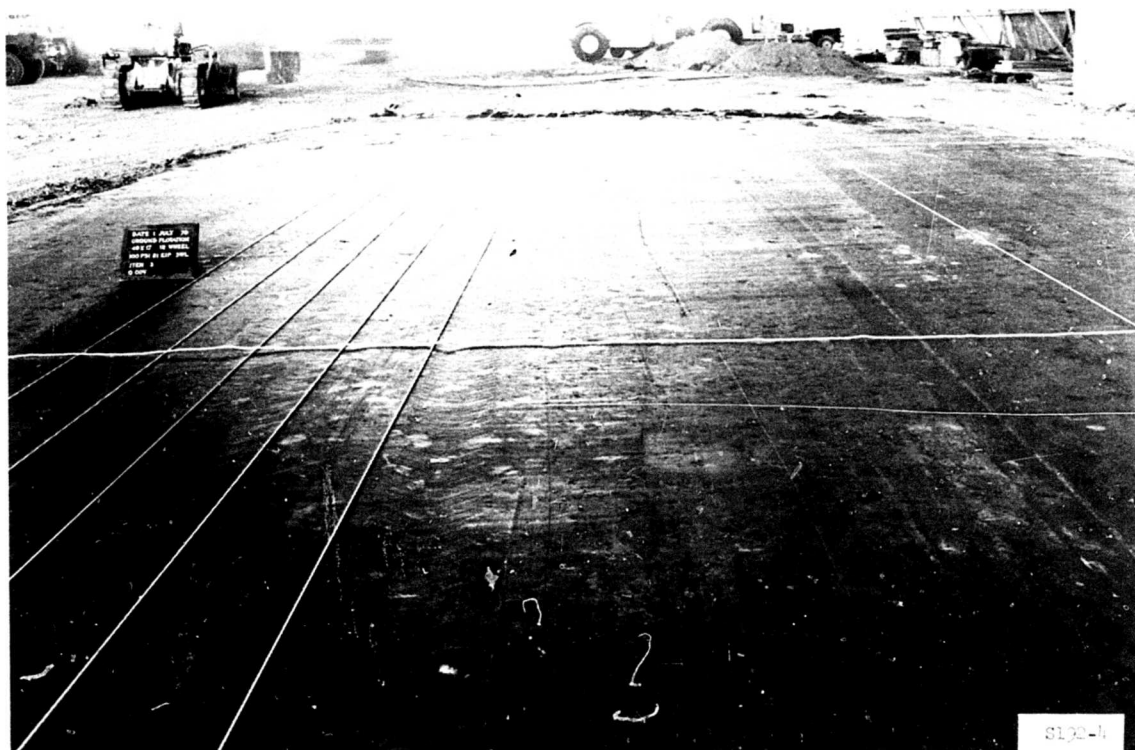
Photo 6. Test section 1, item 3, prior to traffic

21. Item 3 prior to traffic is shown in photo 6. Severe rutting developed immediately with the application of test traffic, and the item was considered failed after one forward and one backward pass of the load cart in the same path. Failure in terms of coverages may then be considered to be between 4 and 8 coverages. For this study, failure was considered to be at 8 coverages (photo 7).

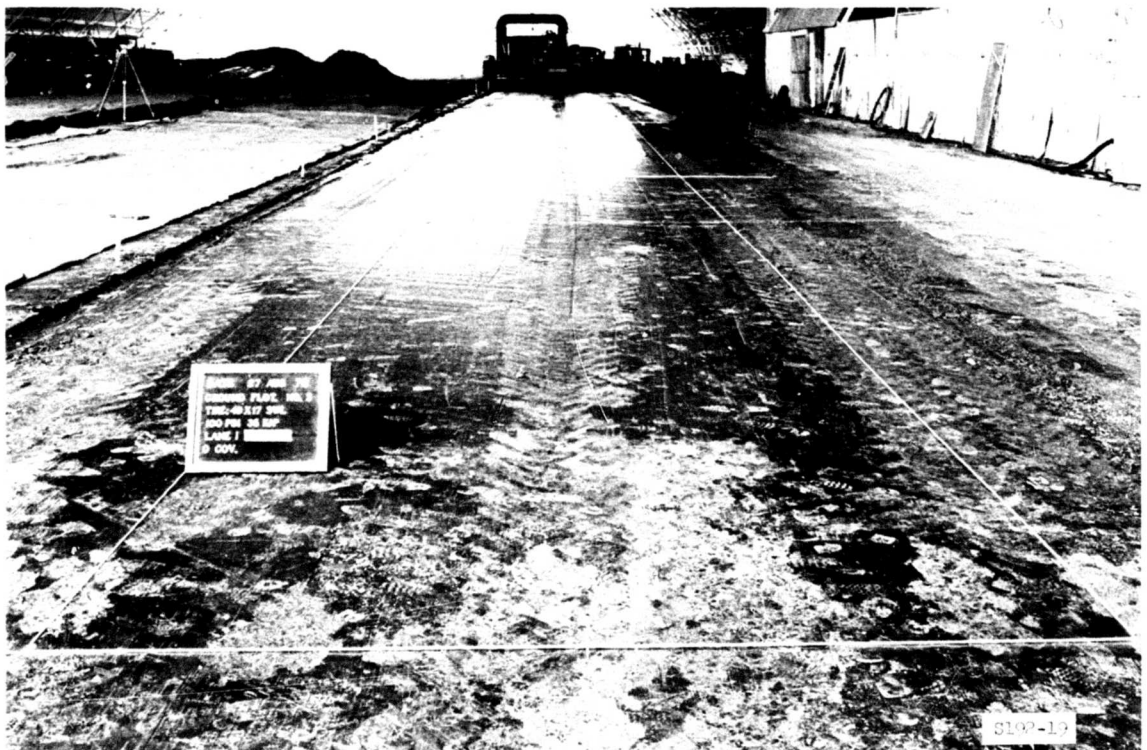
Photo 8. Test section 2, lane 1, prior to traffic

25. Lane 1 was trafficked with a 35,000-lb single-wheel load on a tire inflated to 100 psi, and lane 2 was trafficked with a 252,000-lb load on the 12-wheel C-5A gear with tires inflated to 100 psi. Lane 1 of test section 2 prior to traffic is shown in photo 8.

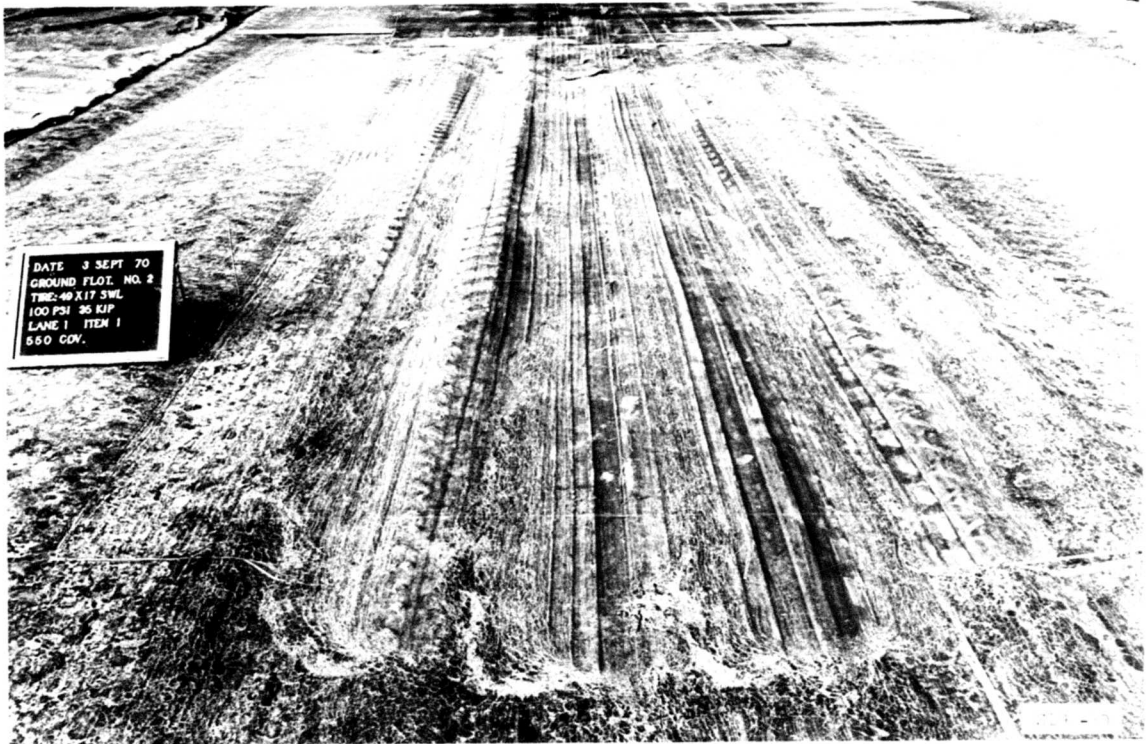
Photo 9. Test section 2, lane 1, item 1, after failure at 550 coverages

26. Item 1. Item 1 held up well under traffic, with only minor rutting and gradual subsidence. The deformation increased slowly until at 550 coverages the item was considered failed based on a differential deformation exceeding 4 in. Photo 9 shows item 1 at 550 coverages.

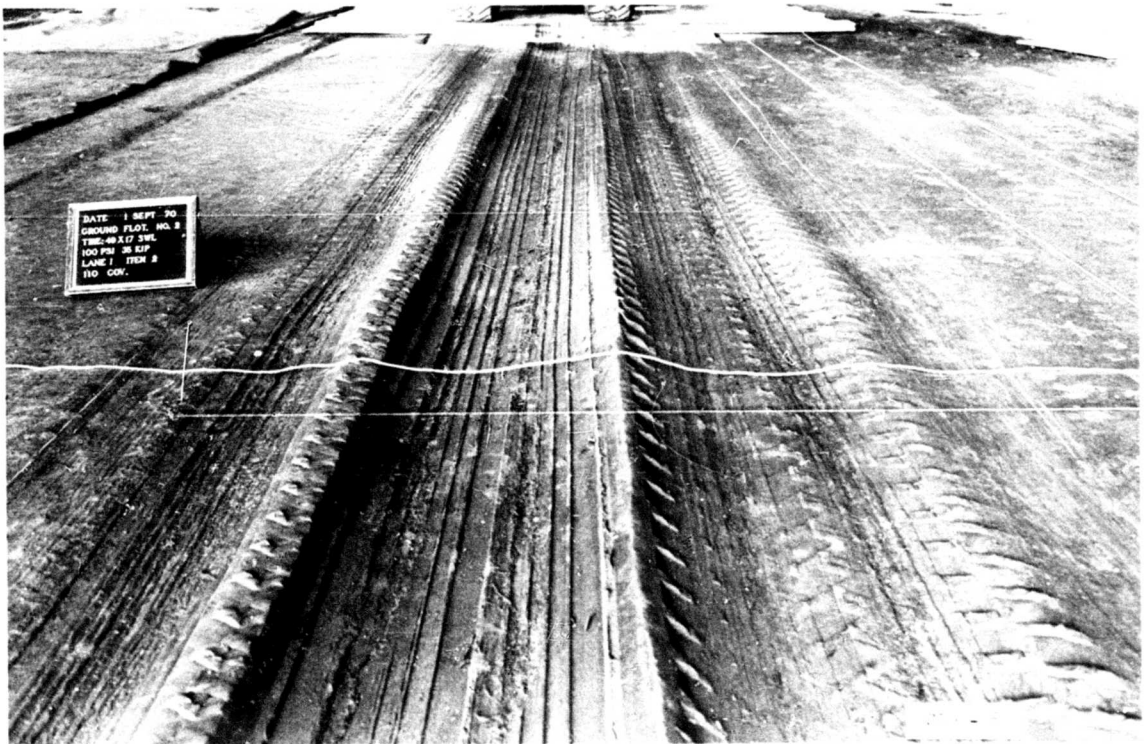
Photo 10. Test section 2, lane 1, item 2, after failure at 110 coverages

27. Item 2. Rutting developed at a moderate rate in item 2 until the item was considered failed at 110 coverages. At this time, the average rut depth was 3 in., and the maximum rut depth was greater than 4 in. (photo 10).

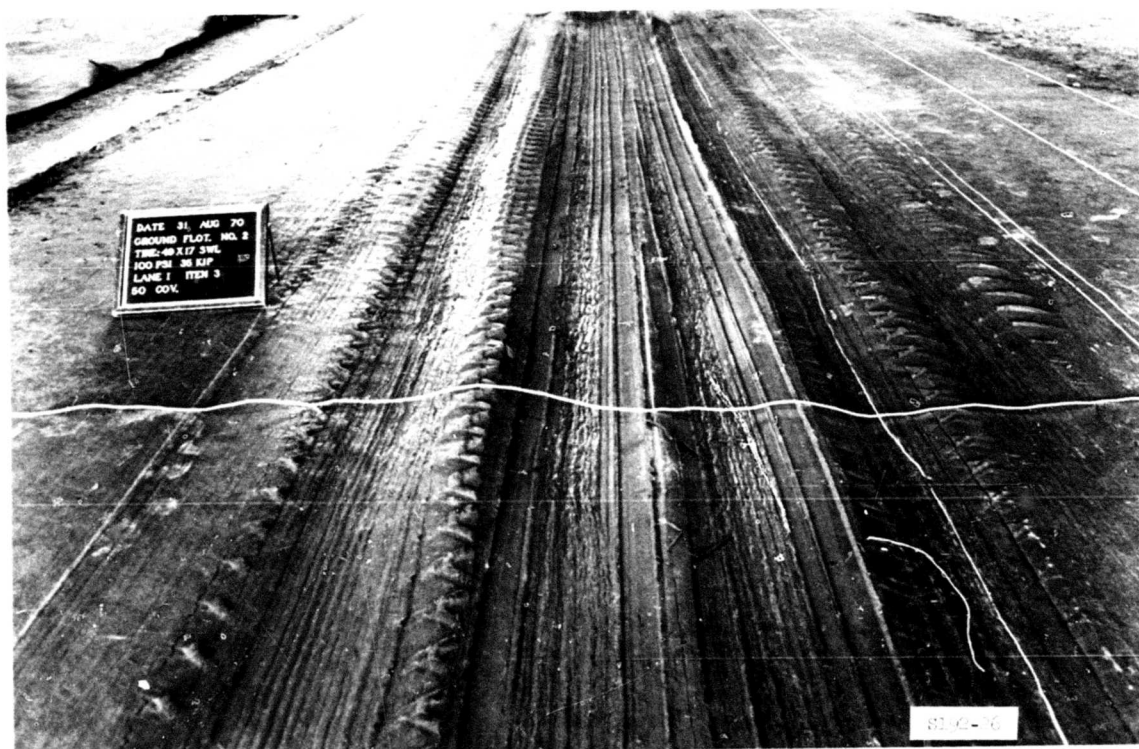
Photo 11. Test section 2, lane 1, item 3, after failure at 50 coverages

28. Item 3. Severe rutting developed in the early stages of traffic, and item 3 was considered failed at 50 coverages. Photo 11 shows item 3 at failure.

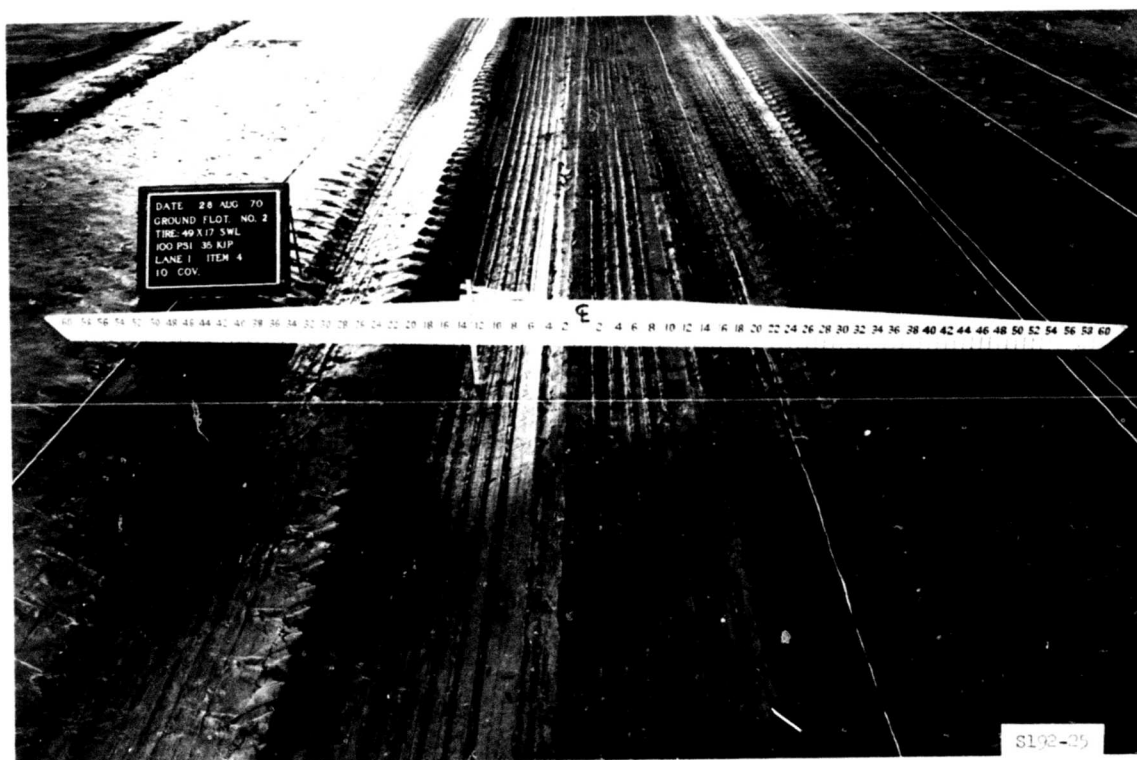
Photo 12. Test section 2, lane 1, item 4, after failure at 10 coverages

29. Item 4. The initial passes caused very severe rutting, and at 10 coverages, item 4 was considered failed. Photo 12 shows item 4 at failure.

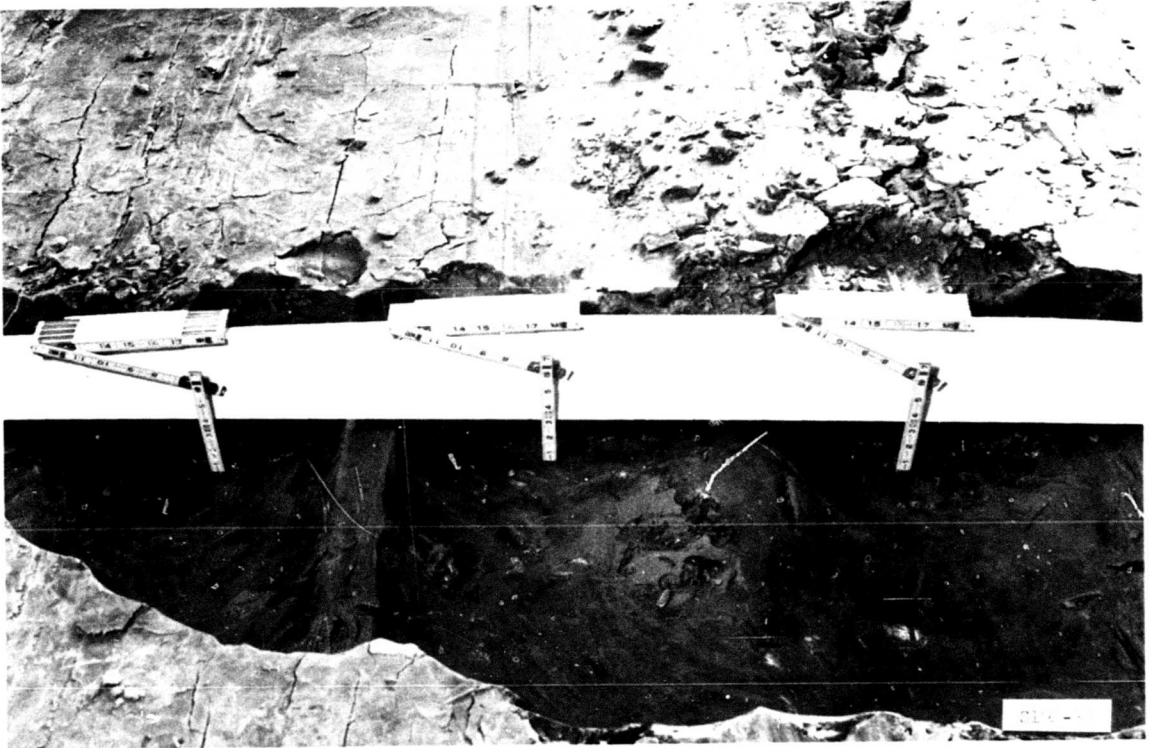
Photo 13. Typical subgrade deformation at failure in test section 2, lane 1

31. Subgrade deformation (items 1-4). Typical cross sections of the interface of the two soil layers in each item are shown in plate 8. These data indicate that the failures noted in the surface of each item were contributed to by deformation in the soil subgrade. Photo 13 shows typical subgrade deformation upon failure of an item.

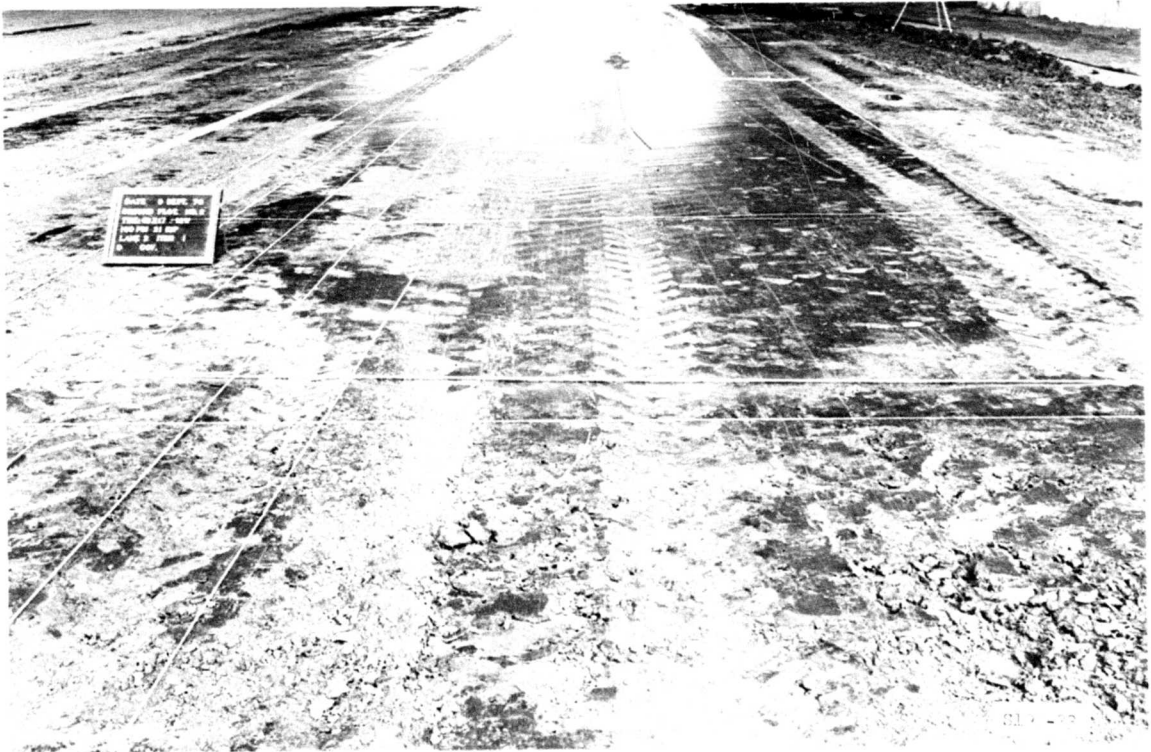
Photo 14. Test section 2, lane 2, prior to traffic

33. Test lane 2 (see plate 2 and tabulation in paragraph 24) prior to traffic is shown in photo 14.

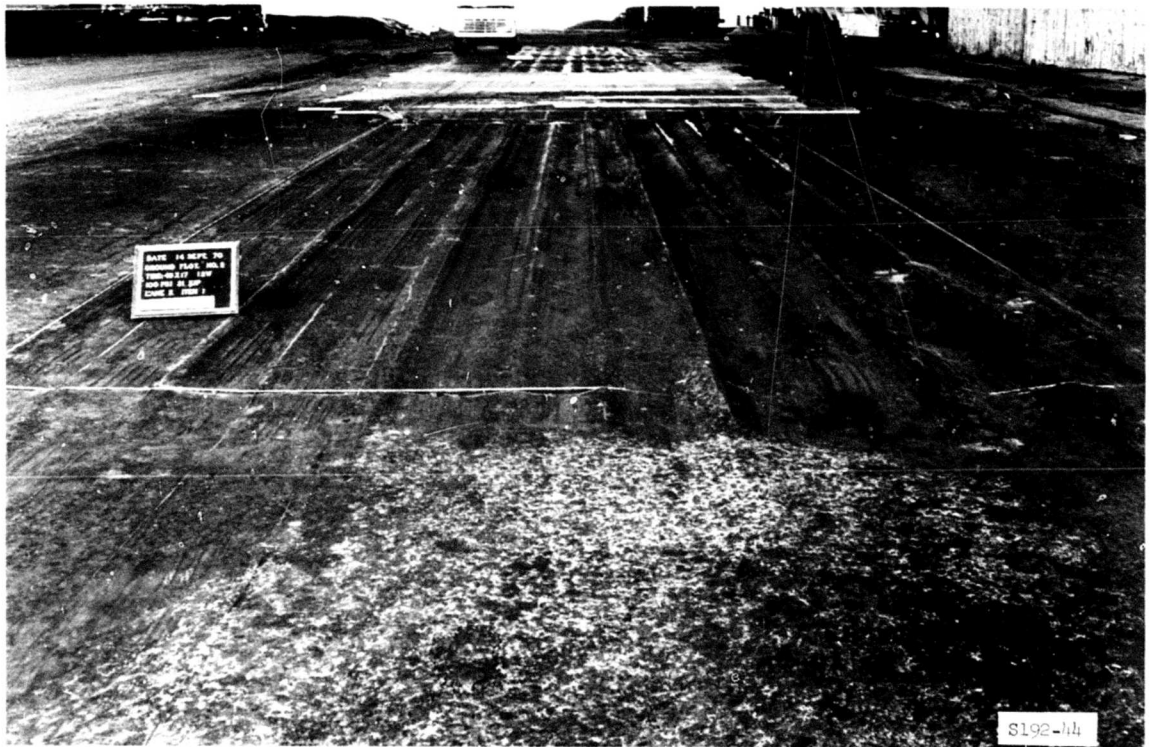
Photo 15. Test section 2, lane 2, item 1, at failure after 228 coverages

34. Item 1. Rutting remained negligible in item 1 for about 100 coverages of traffic; however, at this point, rutting began to increase significantly, and at 228 coverages the item was judged failed. Photo 15 shows item 1 at failure.

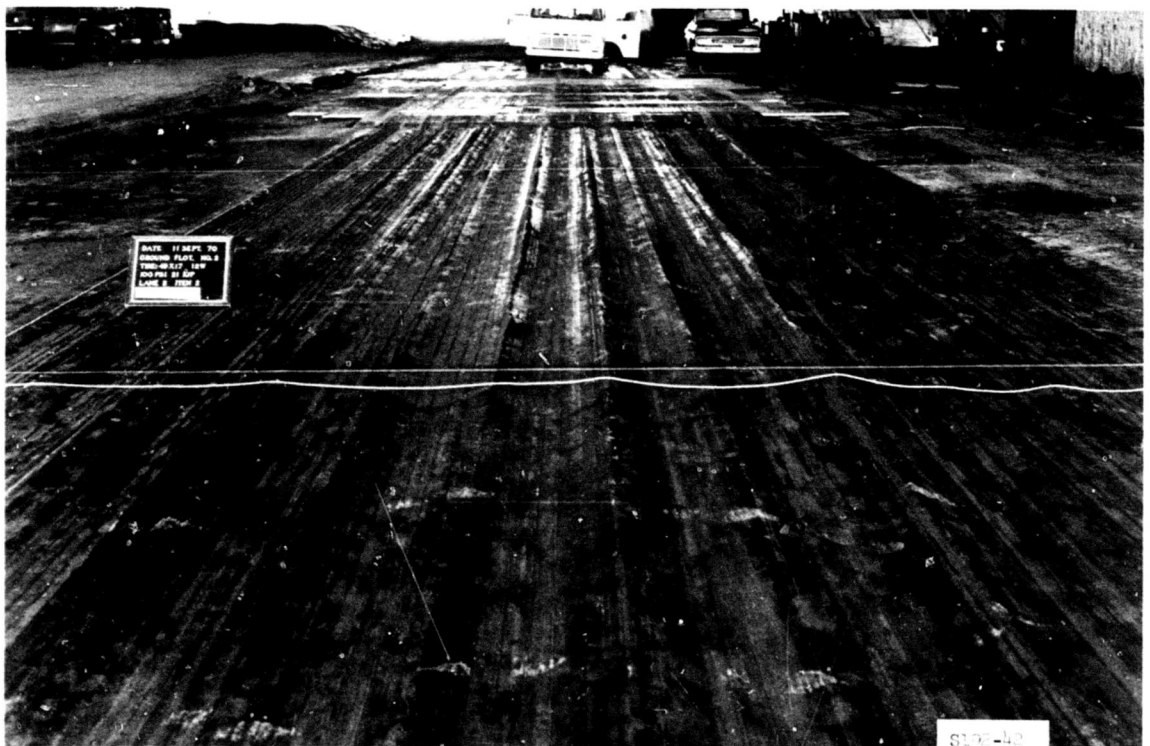
Photo 16. Test section 2, lane 2, item 2, at failure after 76 coverages

35. Item 2. Very slight rutting occurred in item 2 upon application of traffic and increased until failure occurred at 76 coverages. Photo 16 shows item 2 at failure.

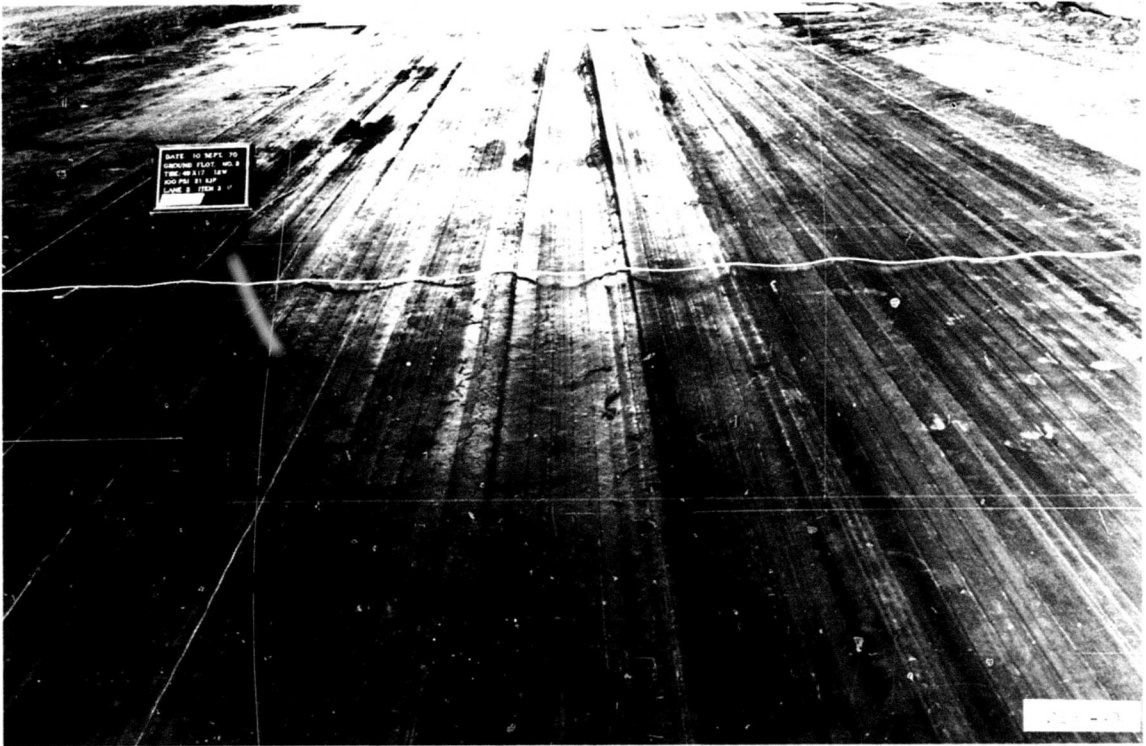
Photo 17. Test section 2, lane 2, item 3, at failure after 40 coverages

36. Item 3. Significant rutting took place in item 3 upon application of the initial pass of traffic, and at 40 coverages the item was considered failed. Photo 17 shows item 3 after failure.

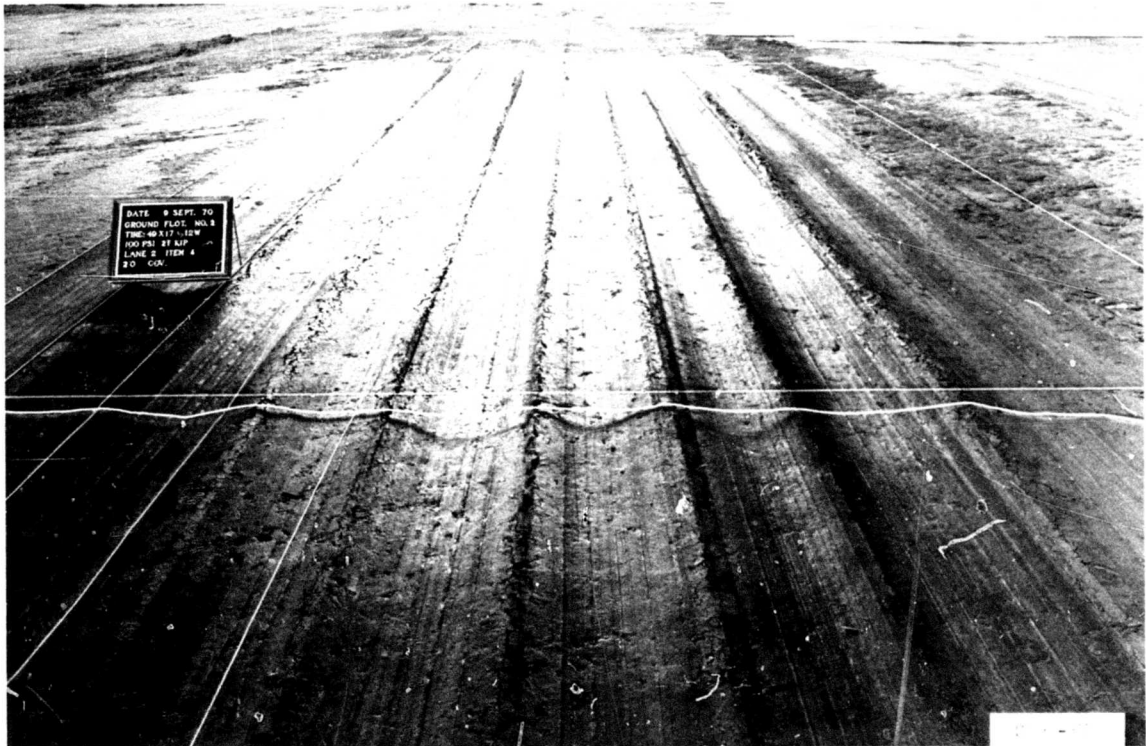
Photo 18. Test section 2, lane 2, item 4, at failure after 20 coverages

37. Item 4. Severe rutting in item 4 resulted from the first pass of the tracking vehicle, and after 20 coverages the item was judged failed. Photo 18 shows item 4 after failure.

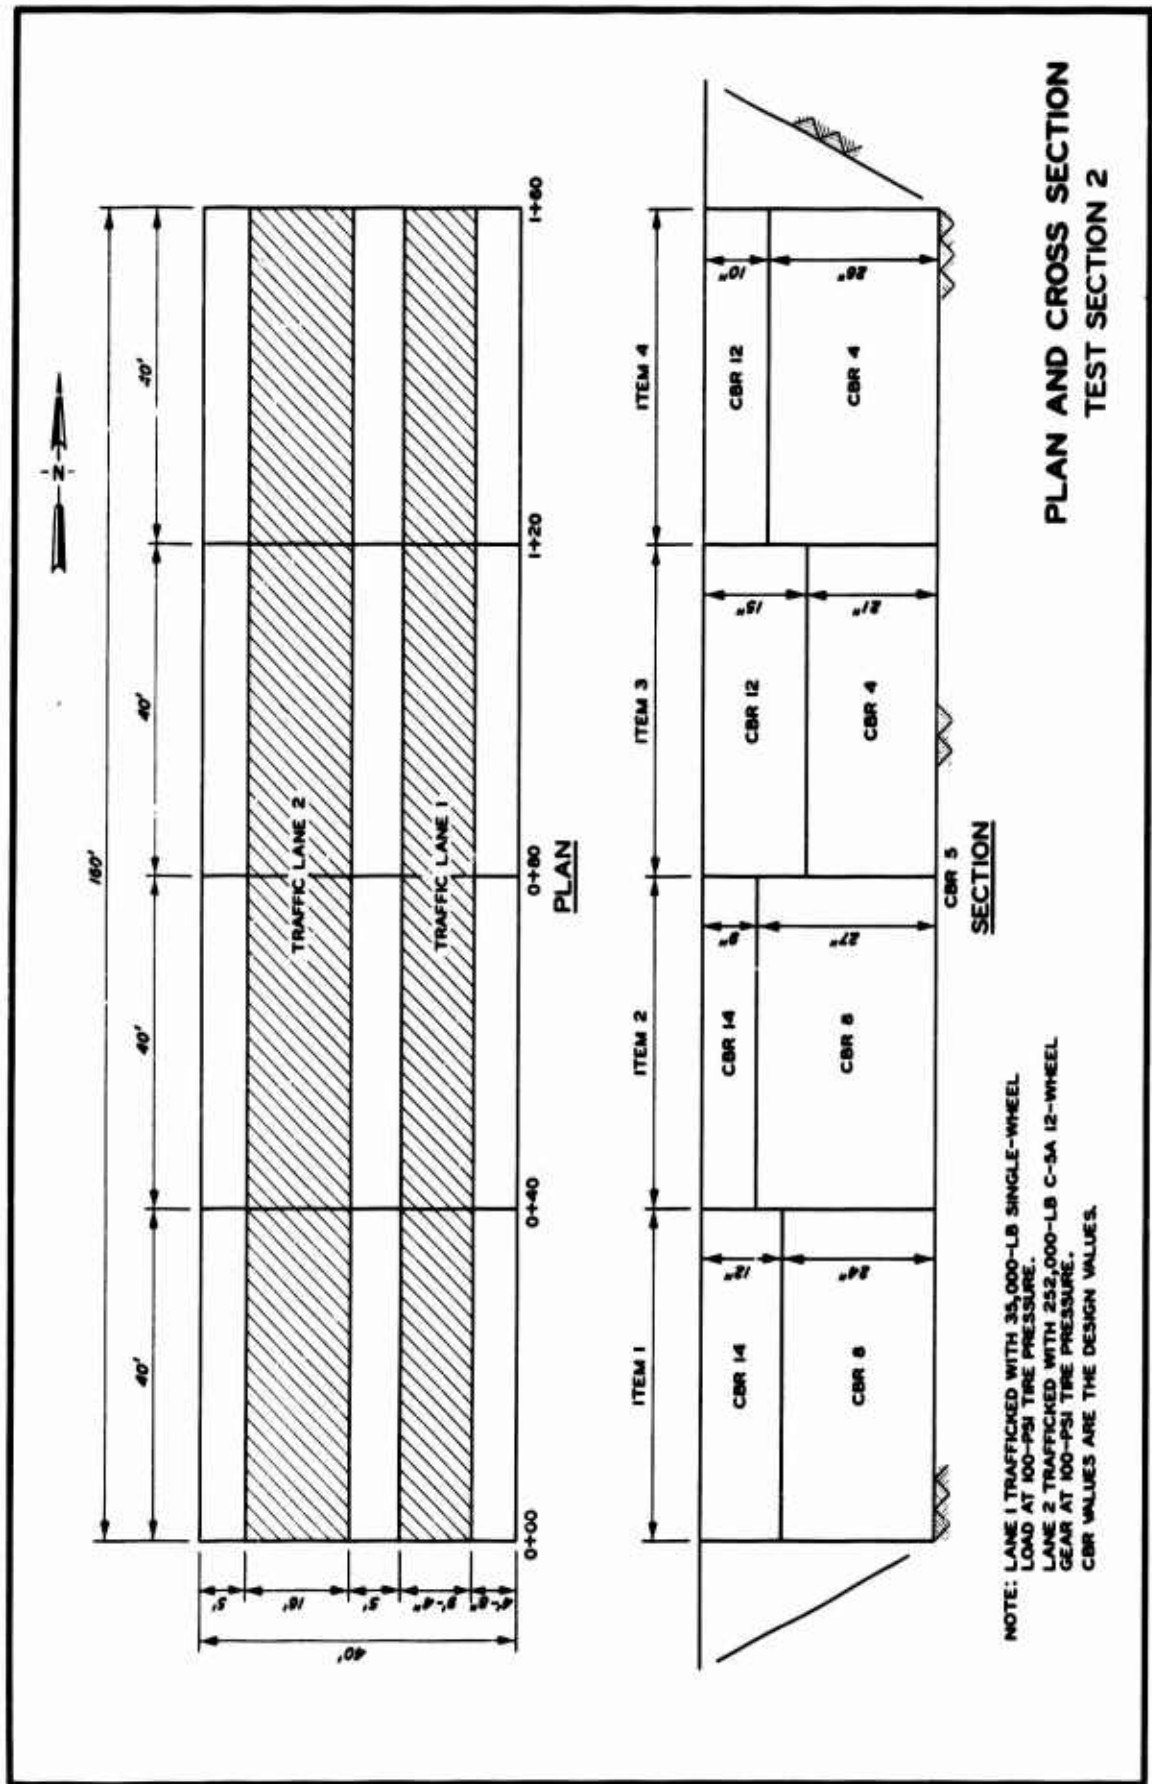
PLATE 2

24. Test section 2 was constructed with two traffic lanes consisting of four items each. A brief description of the test section is presented in the tabulation below, and a plan and cross section of the test section are shown in plate 2.

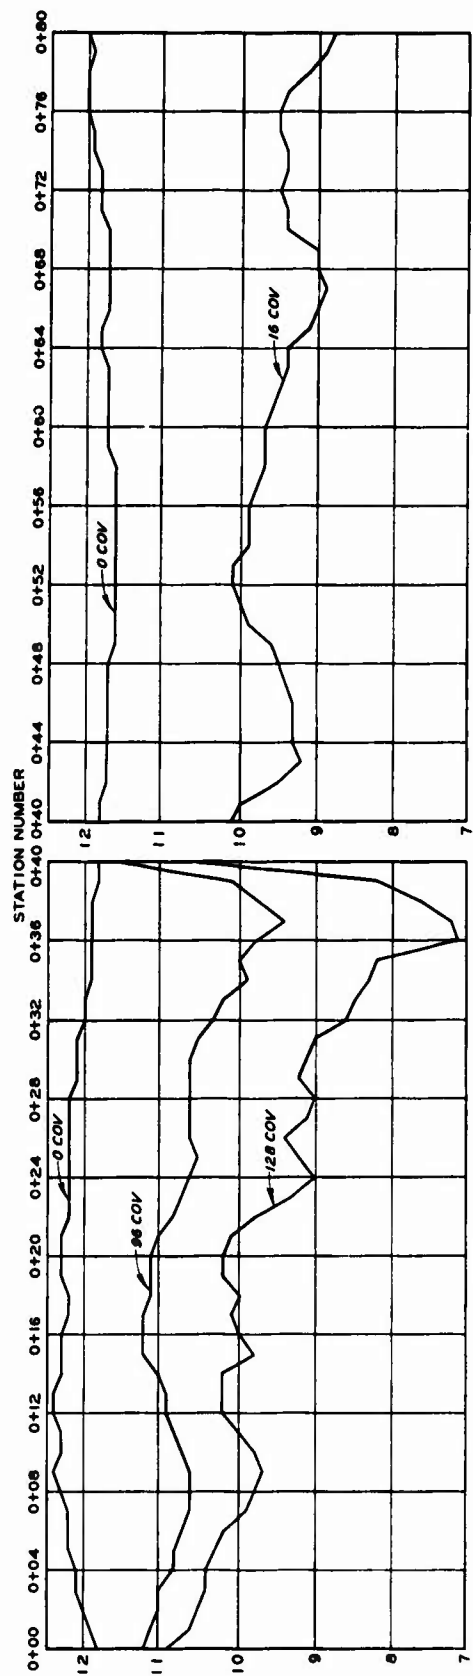
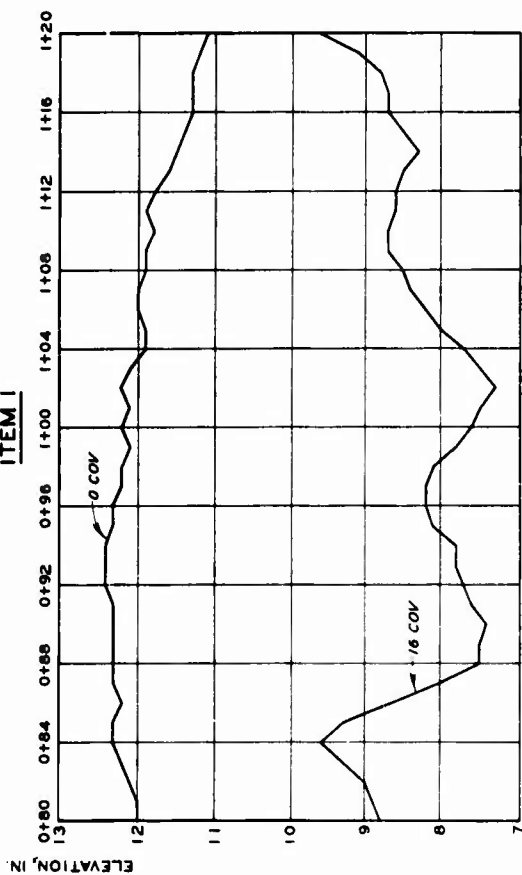
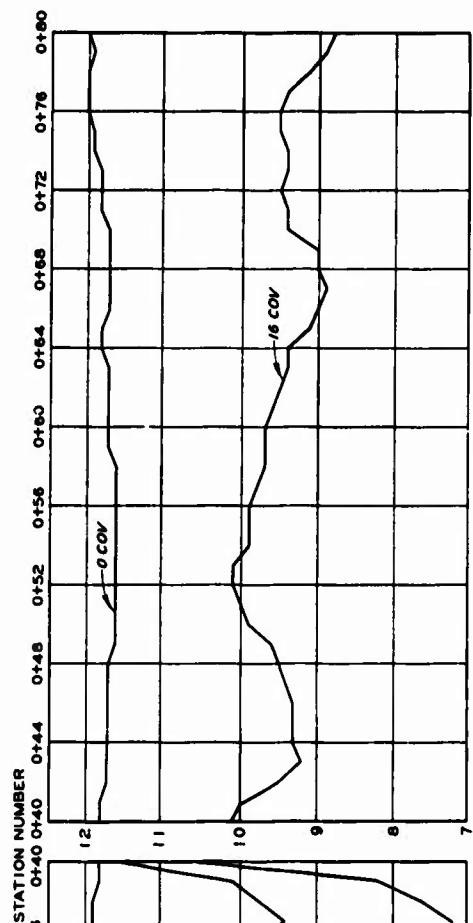
PROFILES
TEST SECTION I

along the center line of each item at various coverage levels in items 1-3 are shown in plate 5. The profile for item 3 is for 16 coverages, although failure occurred at 8 coverages.

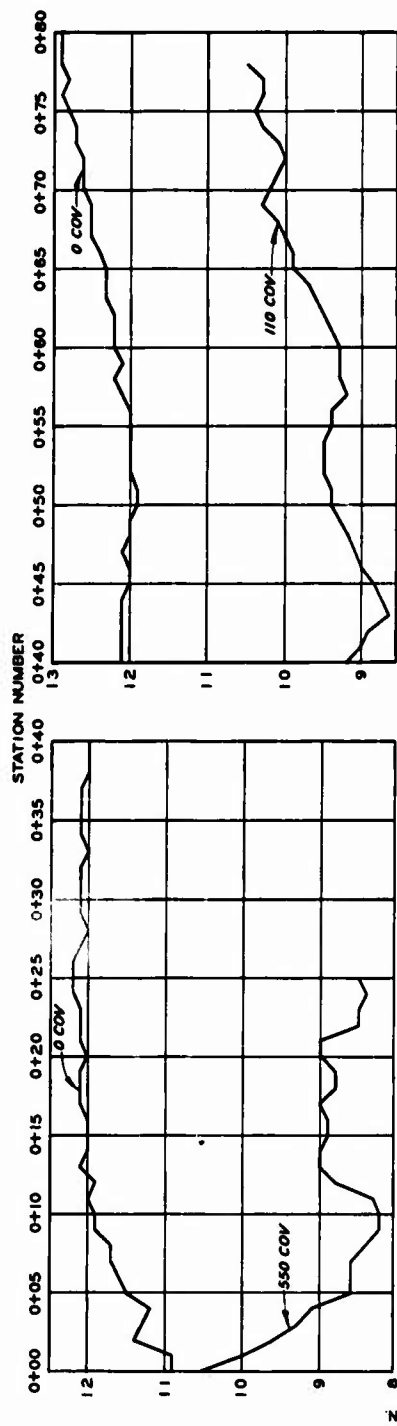
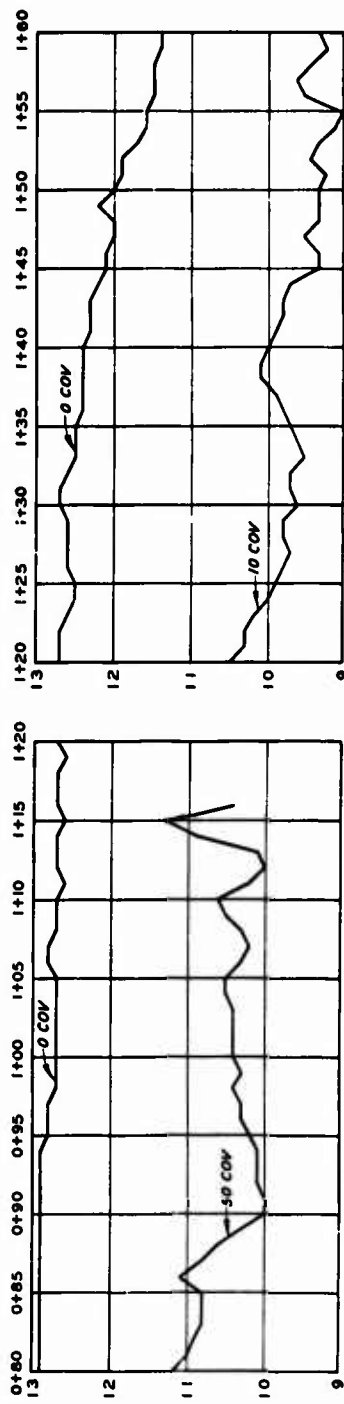
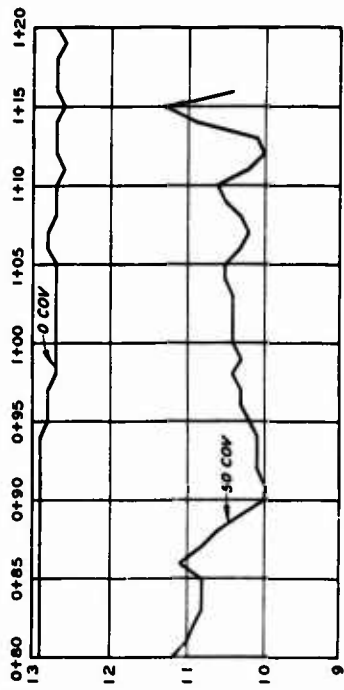
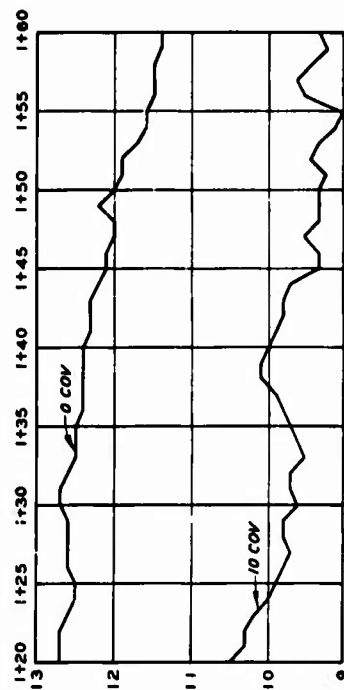
PROFILES
TEST SECTION 2, LANE 1

30. Surface deformation and rutting (items 1-4). Typical cross-sectional elevations of items 1-4 of lane 1 are shown in plate 6. These data indicate the severe surface deformation that had occurred in each item at failure. Rut depth measurements taken in each item at failure are shown in table 4. These values indicate that the average rut depths of the items at failure were each at least 3 in. and that the maximum rut depths were at least 4 in. Profile elevations taken along the center line of each item at 0 coverages and after failure are shown in plate 7.

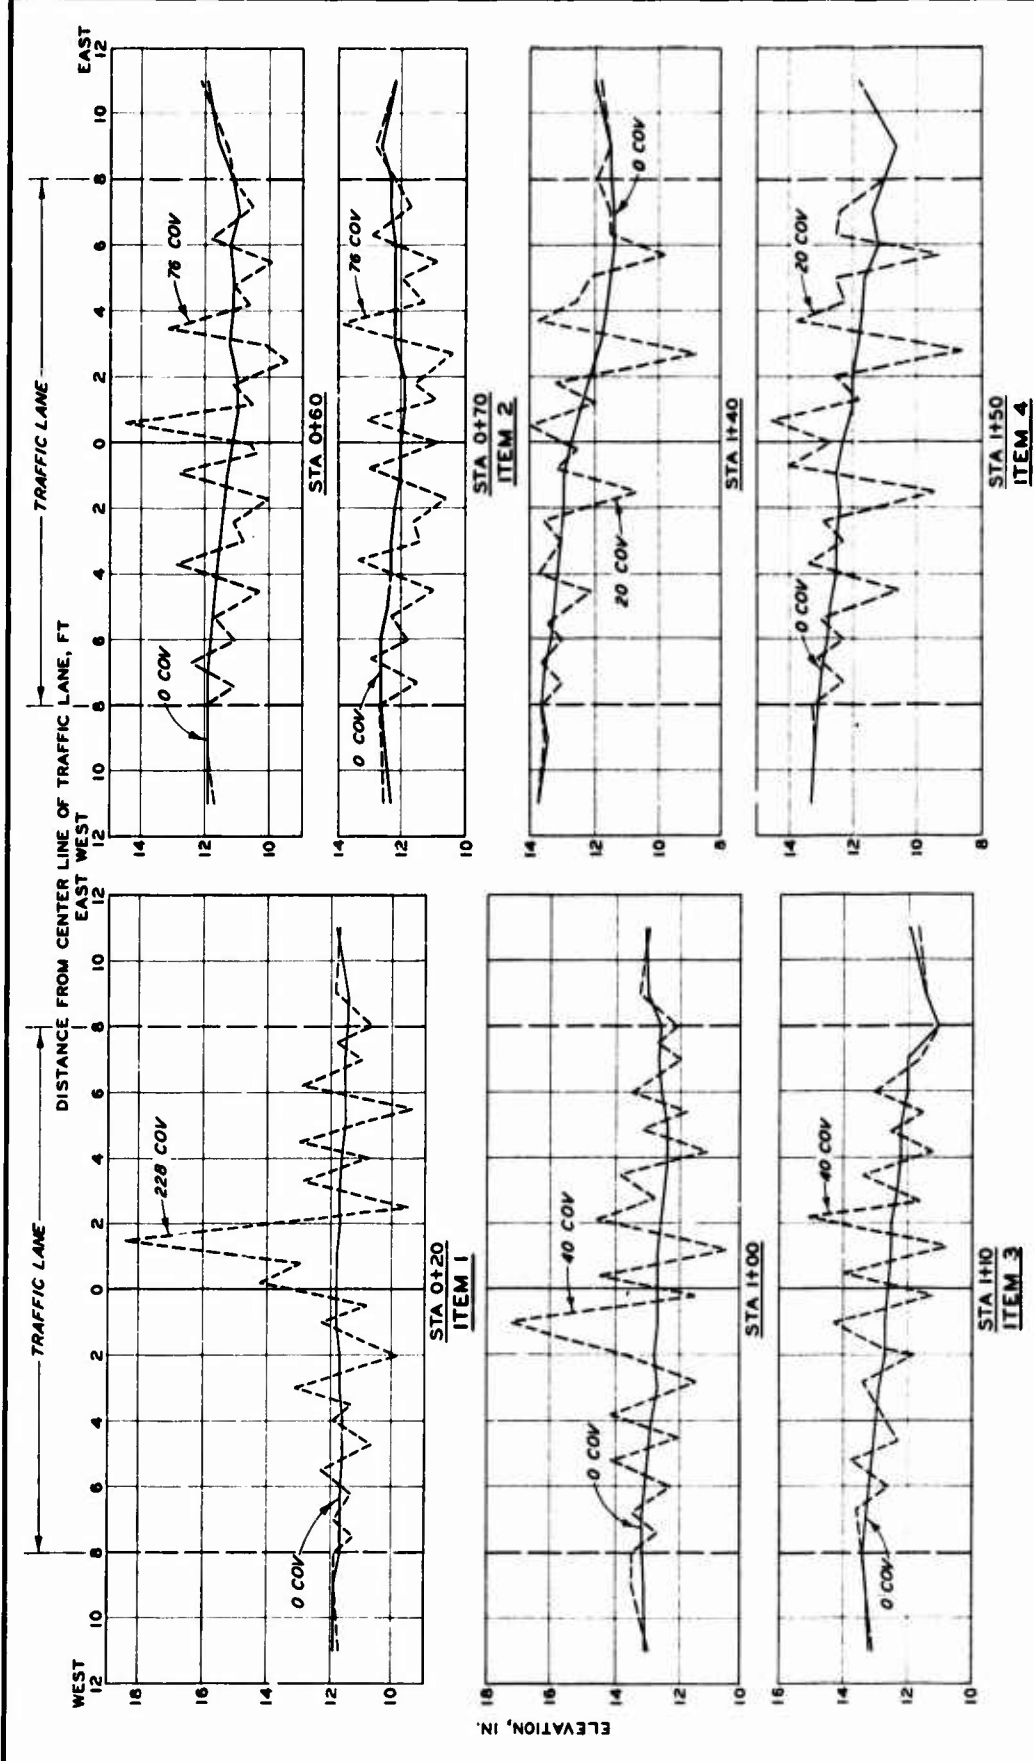
CROSS SECTIONS
TEST SECTION 2, LANE 2

38. Surface deformation and rutting (items 1-4). Typical cross sections of items 1-4 are shown in plate 9. These data show the deformation that occurred in each item at failure. Rut depth measurements taken at failure in each item are shown in table 4 and indicate that the average depths were at least 3 in. and that maximum depths all exceeded 4 in. Profile elevations taken along the center line of each item prior to traffic and upon failure are shown in plate 10.
